BeSafe press release

Recall to repair of BeSafe iZi Go X1 (NOT BeSafe iZi Go Modular X1 i-Size)

Potential risk when using in combination with ISOfix base.
It is safe to use the seat when installed with the vehicle seat belt.

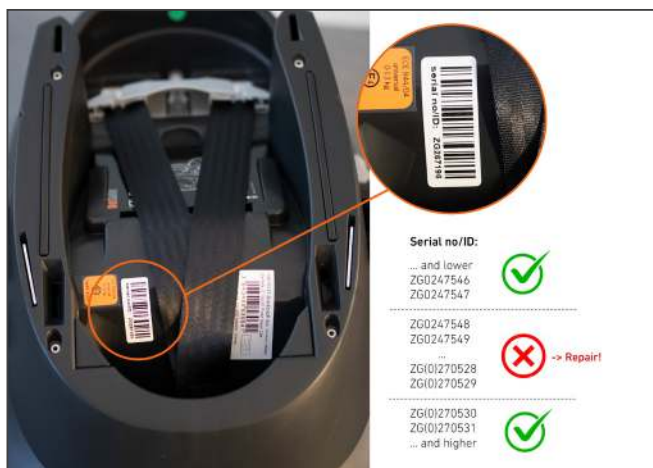
If you have bought a new BeSafe iZi Go X1 from 9th March 2020 on, please check that it has the “CHECK 2020” sticker next to the serial number label. Then this seat has been repaired and is perfectly safe to use.

1. Check if your baby car seat is a BeSafe iZi Go X1
2. If yes, check the serial number on your seat
3. If your serial number is between **ZG0247548** and **ZG(0)270529**, please contact your nearest selected BeSafe retailer immediately to have the seat repaired. The repair takes no longer than 10 minutes. Find the selected retailers for repair here:
<http://bit.ly/BeSafe-iZiGoX1-Recall-UK>
4. Install the seat with the vehicle belt in the meantime

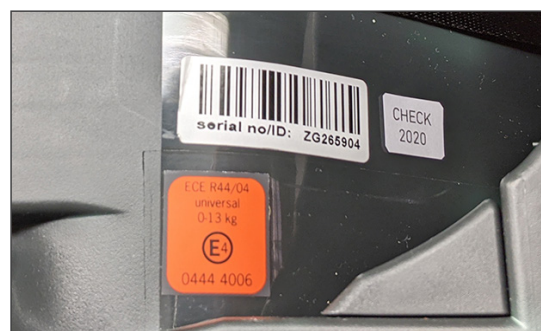
Turn your BeSafe iZi Go X1 seat upside down. On the bottom side you find a white label saying “Serial no/ID” followed by a number with two letters and 6 or 7 digits. If your serial number has 6 digits, you would just add a 0 in the front to match the 7-digit-format.

If your serial number is below **ZG0247548** or above **ZG(0)270529**, your product is not affected and perfectly safe to use.

If your serial number is between **ZG0247548** and **ZG(0)270529** and does NOT have a “CHECK 2020” sticker, your product is affected and must be repaired.

If your serial number is between **ZG0247548** and **ZG(0)270529** and DOES have a “CHECK 2020” sticker, then the seat has already been repaired and is perfectly safe to use.
